## Description of the passive air supply system based on ventilation windows supported by chimneys

Rimante Andrasiunaite Cox  
Technical Report

Department of Civil Engineering  
Technical University of Denmark  
2015

Report: BYG R-342

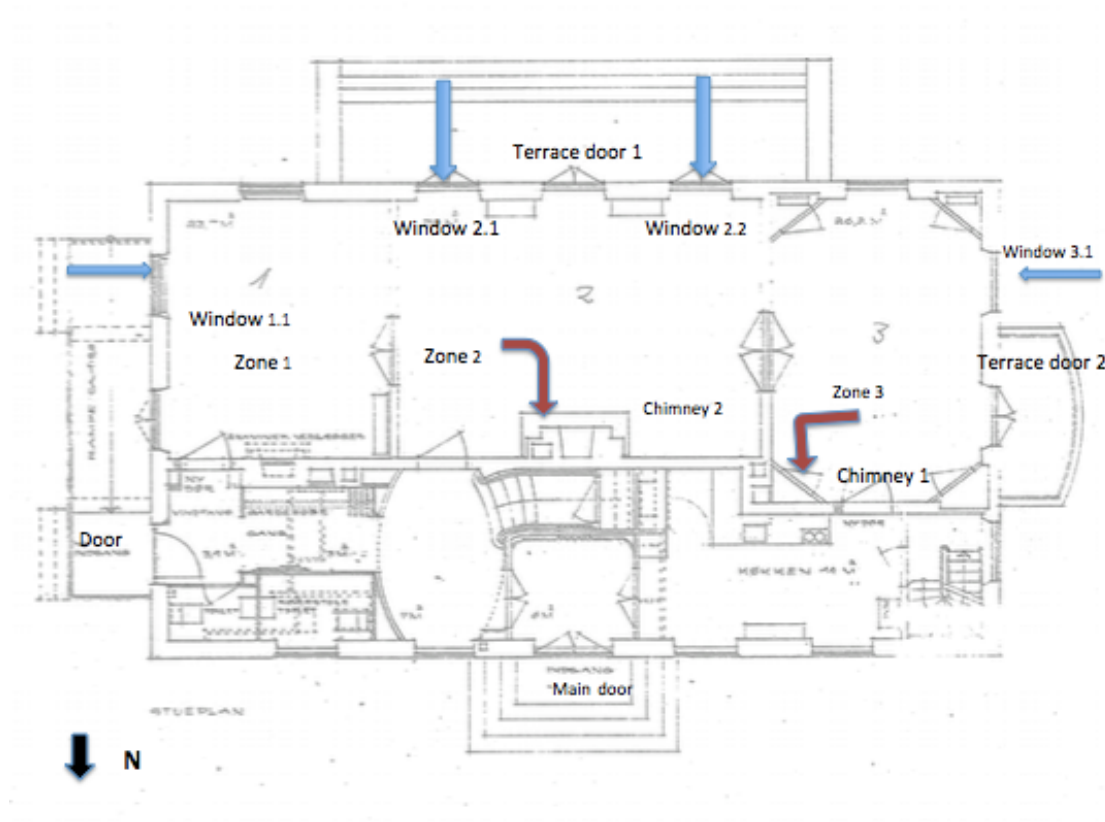
**Figure 1** Diagram showing location of the windows and zones on the ground floor and assumed air movements through the window openings and chimneys.

The installed passive ventilation system is assumed to provide fresh air through 9 ventilation windows shown in Figure 1, 2 and 3, and passively extracted by the

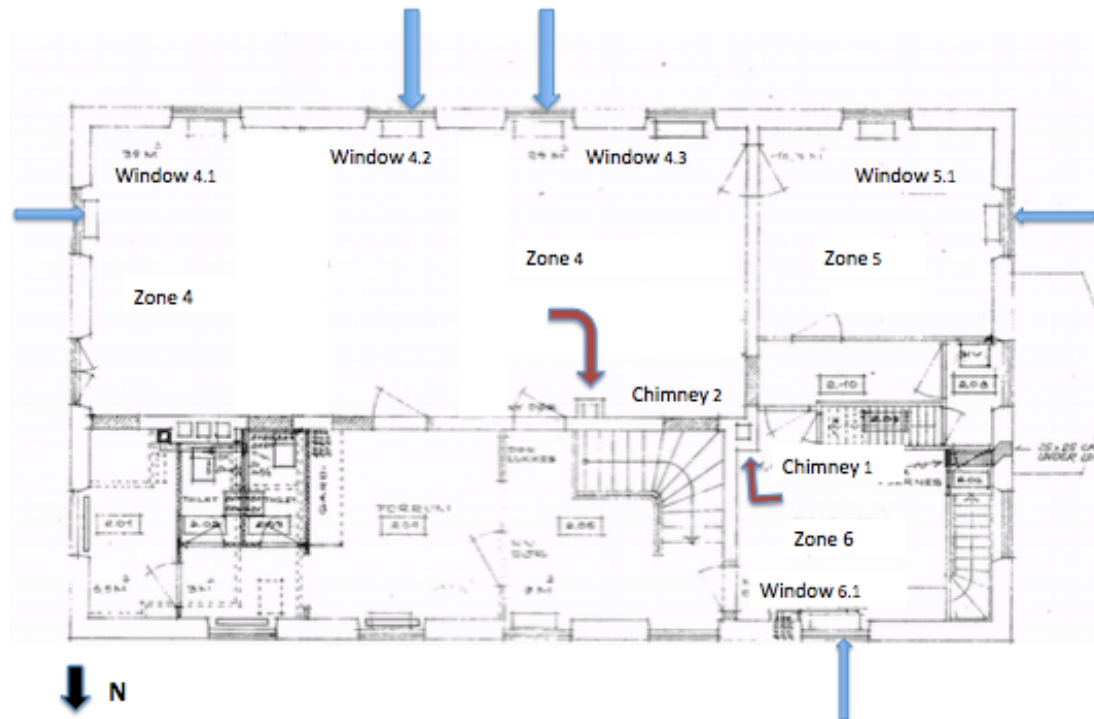
Figure 2 Diagram showing the location of the windows and zones on the 1<sup>st</sup> floor and assumed air movements through the window openings and chimneys.

Zone 4 and zone 5 on the 1<sup>st</sup> floor, as shown in Figure 2, are used as the daycare playroom area, where the local childminders with their children meet and spend the day together. The first floor is occupied with different adults and children nearly every weekday, with a maximum number of 5 adults and 15 children. Similar to the ground floor, the occupancy is between 7AM-5PM. Depending on the weather, the occupants spent some morning hours or afternoon hours outside on the playground. Some of the children have an afternoon nap between 12-14PM outside and some inside in Zone 5. During occupancy Zone 4 is used as a playing and eating area.

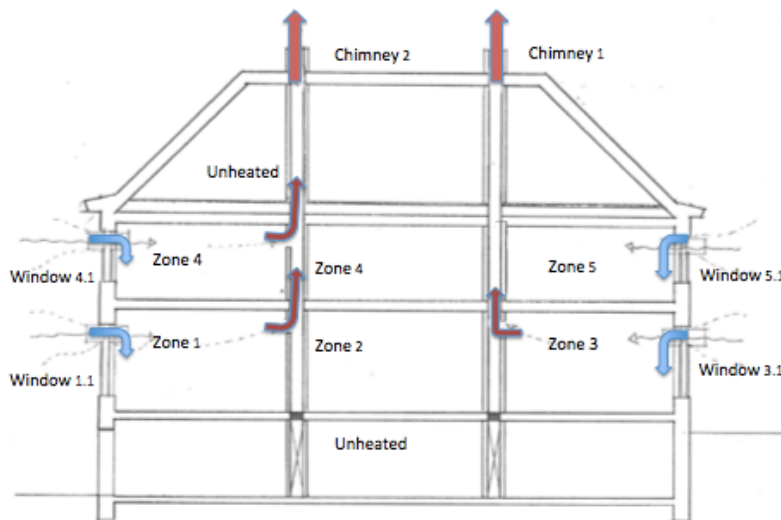
**Figure 3** Diagram showing the fresh air supply through the window and extracts from the chimneys

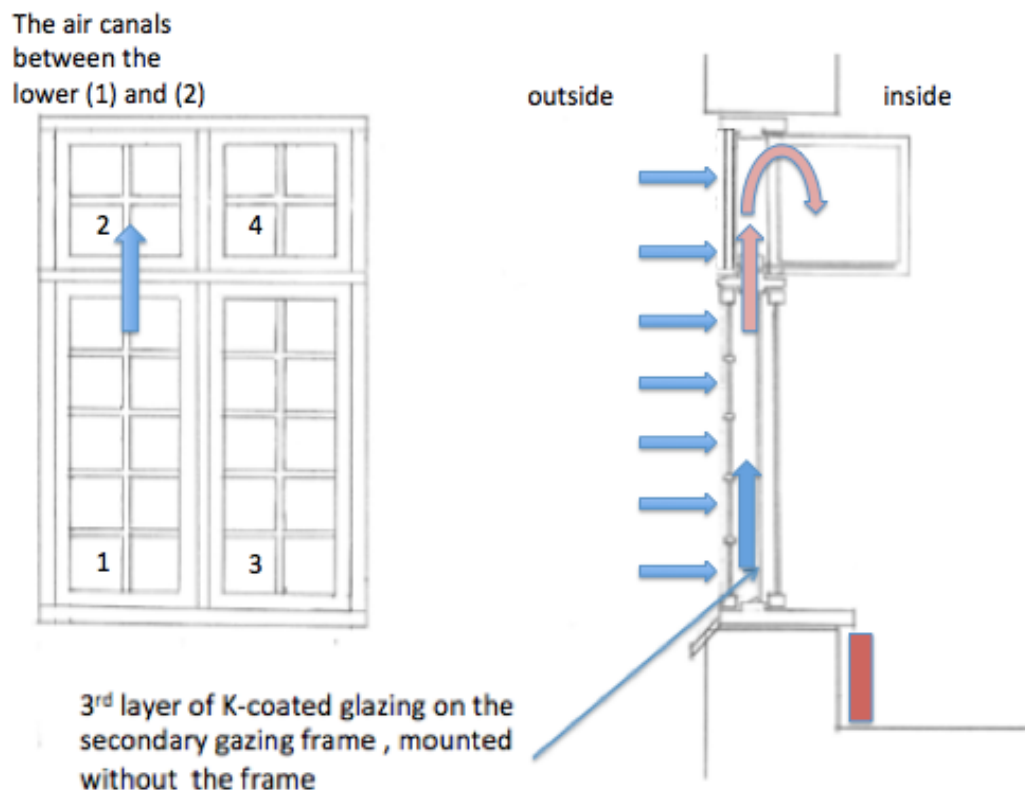
Figure 4 Diagram showing the incoming air during the coldest periods of the air (winter)

During the coldest period of the year the external frames (2) were closed and the internal frame (2) was open as shown in Figure 4. It was assumed that the external frame had leakage through a 1mm gap around the perimeter of the frame (1 and 2). The canals between the lower parts (1) and top parts (2) of the windows in the middle frames were established to ensure that the incoming fresh air through the natural leakage of the external frame of both part (1) and part (2) were working as supply air canals. The canals between part (1) and (2) also allow the air in the gap to move upwards due to the preheating effect of solar radiation or the escaping heat loss from the window, and enter the room slightly warmer than the external temperature. The parts (3) and (4) were not connected to parts (1) and (2) and are therefore not currently used for ventilation.

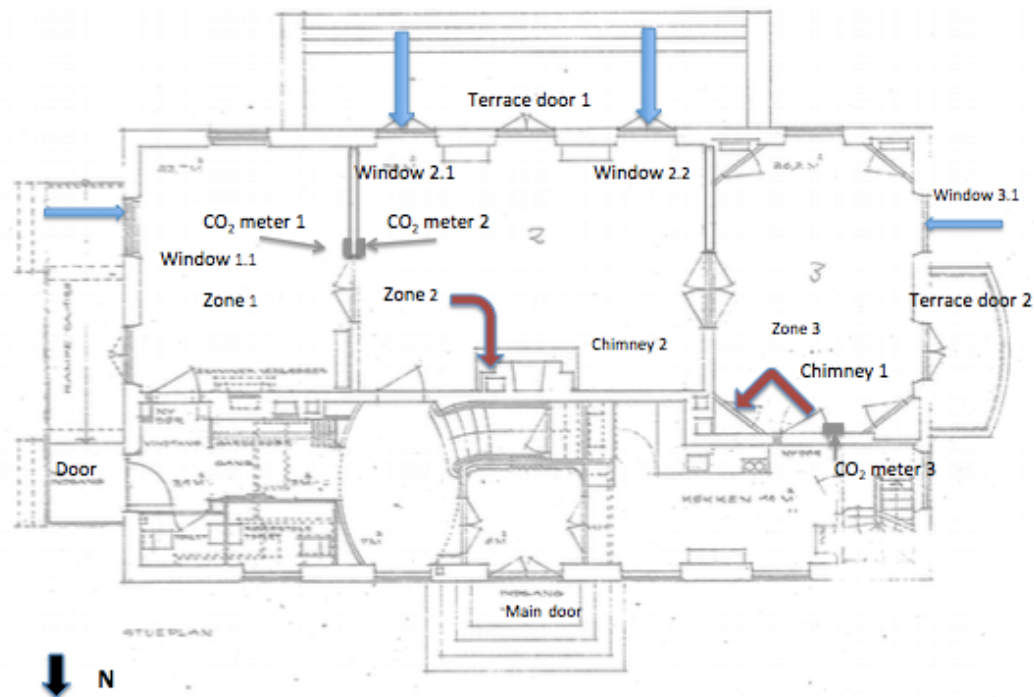
Figure 6 The grey arrows show the location of the CO2 meters, automatically recorded by Windows masters on the ground floor

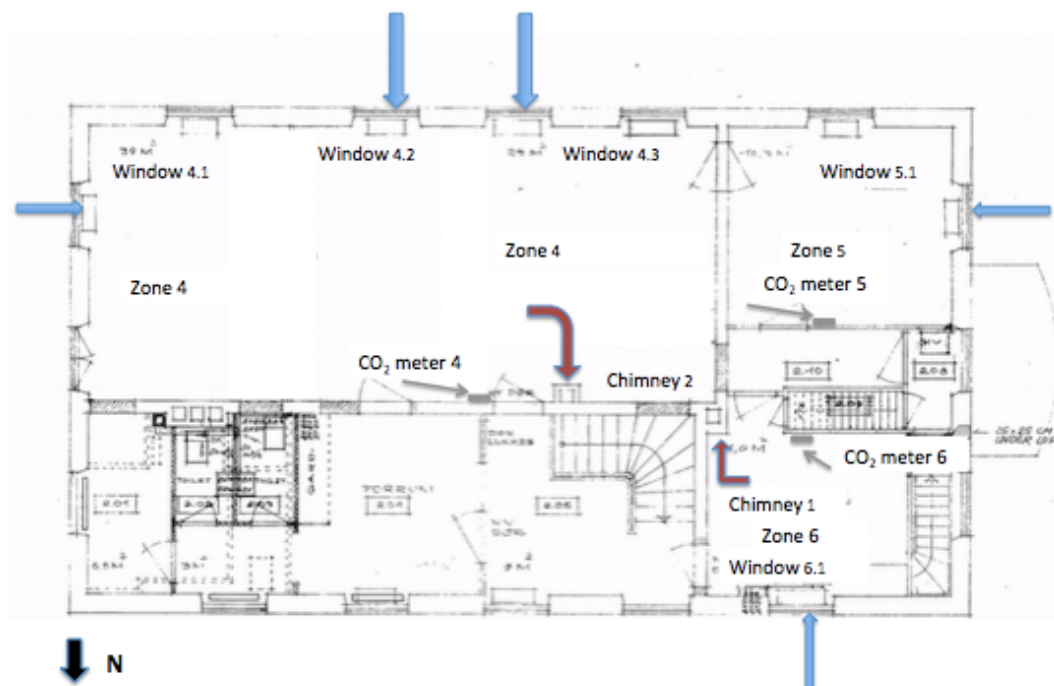
Figure 7 The grey arrows show the location of the CO2 meters, automatically recorded by Windows masters on the first floor

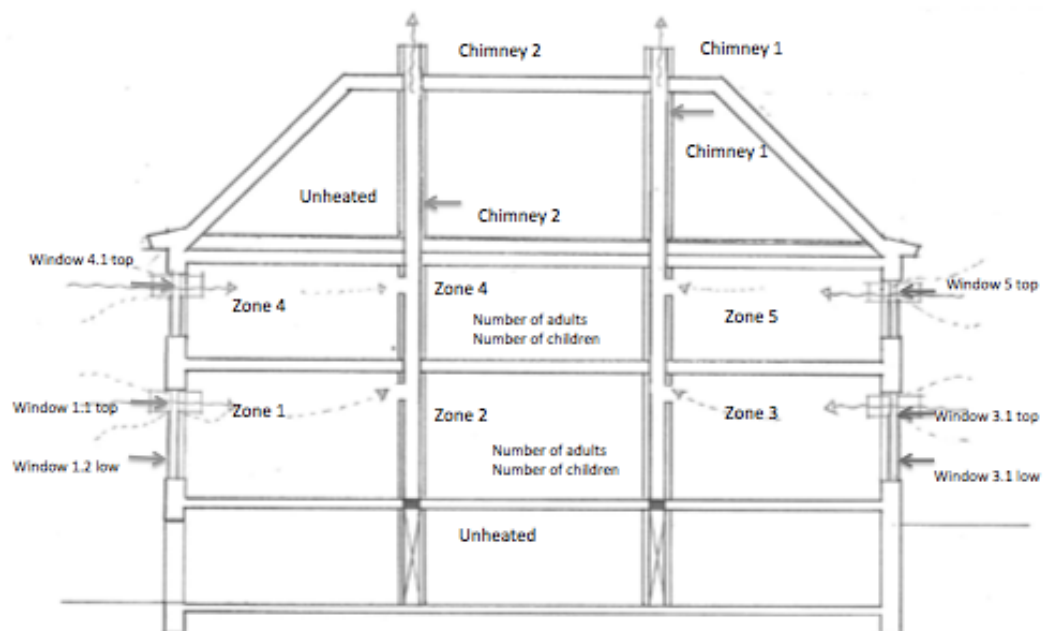
Figure 8 Location of the additional meters installed in all ventilation windows and chimneys during experiments 2 and 3.

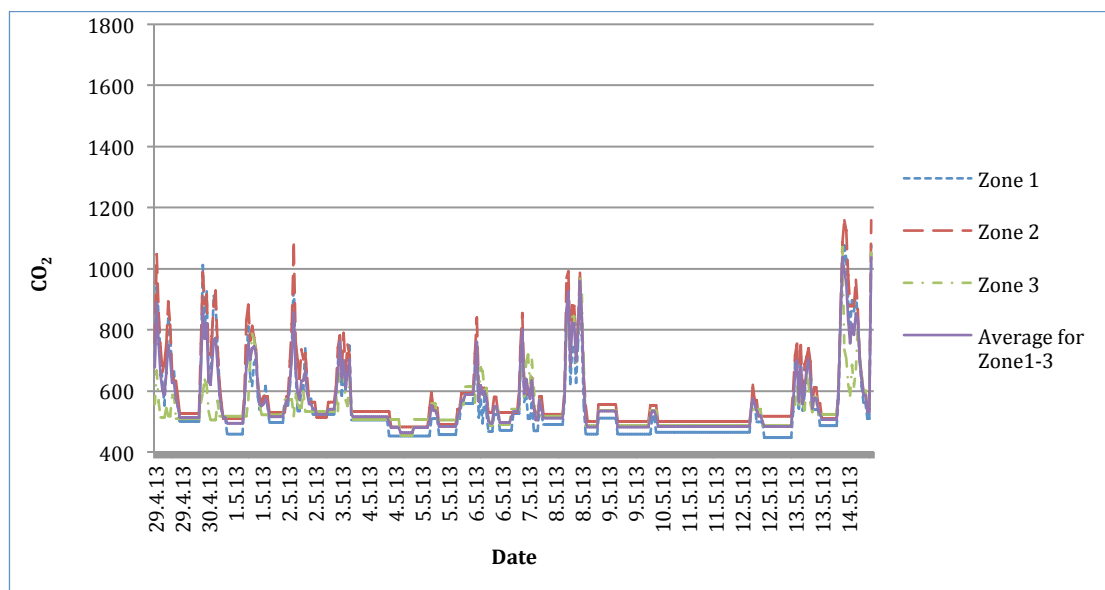
The experiment showed that the air quality on ground floor was good most of the time. During the 16 day period, the CO<sub>2</sub> levels on the ground floor exceeded 1000ppm for a total of 5 hours, on as shown in Figure 10. The CO<sub>2</sub> levels on the first floor exceeded 1000ppm for a total of 14 as shown in Figure 11.

Figure 10 CO<sub>2</sub> concentration on the ground floor during the experiment 1, (27April - 14 May 2013)

The max CO<sub>2</sub> level on the ground floor were recorded at 1159 ppm in the Zone 2 on the 14 of May 2013 between 10-13.

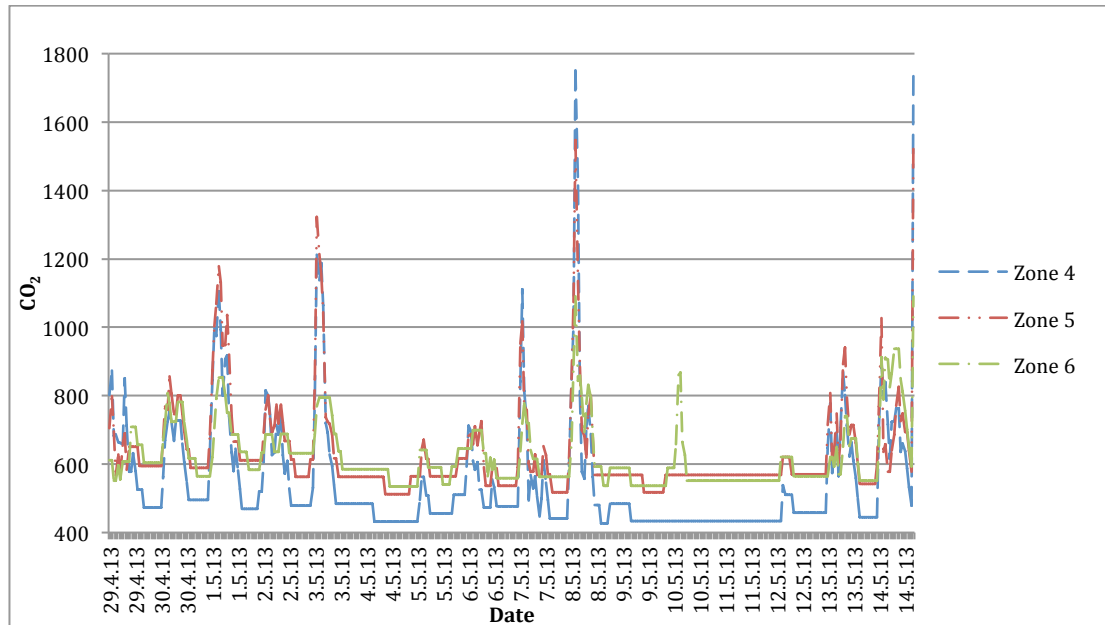
**Figure 11 CO<sub>2</sub> concentration on the first floor during the experiment 1 (27April - 14 May 2013)**

The max CO<sub>2</sub> level on the 1<sup>st</sup> was recorded at 1751ppm on the 8 of May 2013.

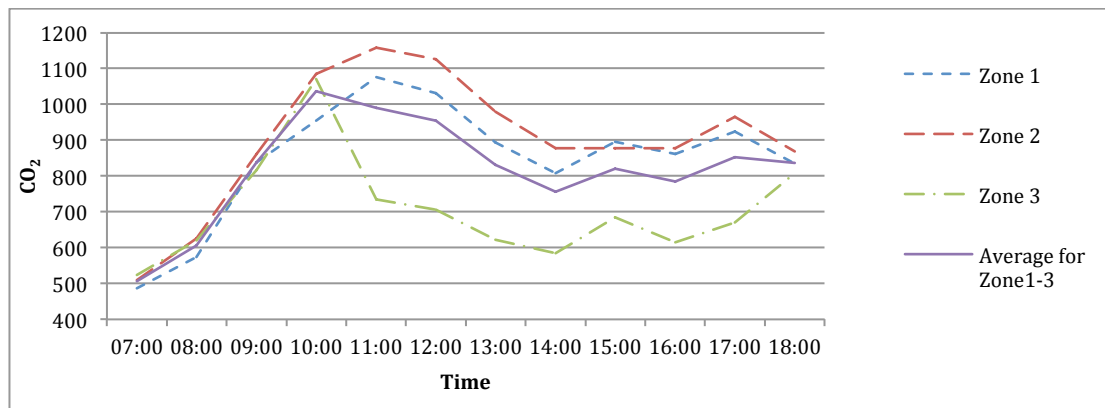
Figure 12 shows the CO<sub>2</sub> concentration on the ground floor during 14 of May 2013.

Figure 12 Hourly CO<sub>2</sub> levels on the ground floor 14 May 2013

To be able to keep the CO<sub>2</sub> levels below 1000ppm, the air change should be 0.7 ach. The measured average CO<sub>2</sub> concentration for 1-3 zones was 1103 ppm, which is considered moderate. Using the actual concentration, it was calculated that the actual air change was 0.6 ach, which is lower than required.

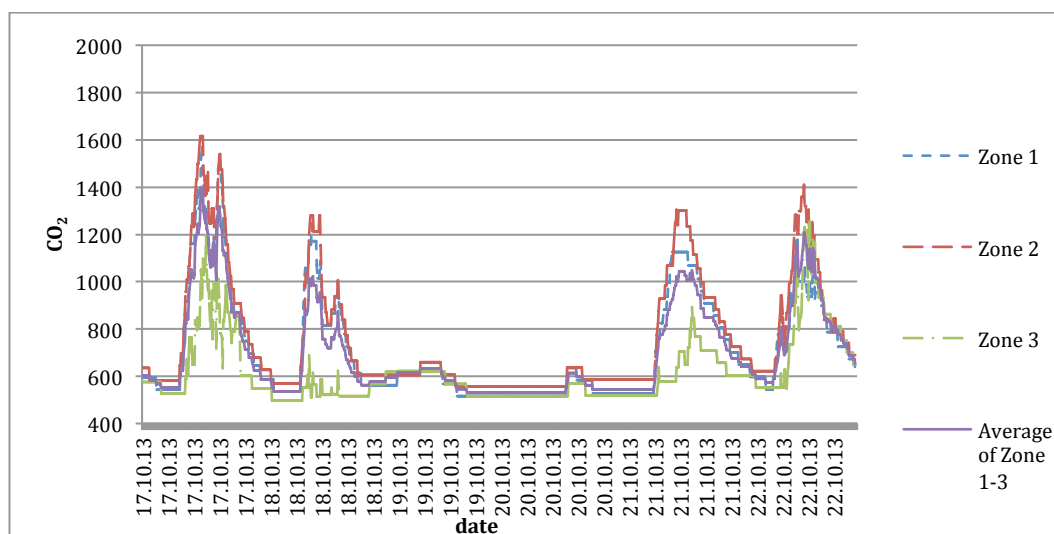
Experiment 2 revealed that the air quality in the building was partly unsatisfactory (above 1000ppm) during the occupancy on the ground floor and worse on the 1<sup>st</sup> floor. During the 4 occupied days the CO<sub>2</sub> levels on both floors exceeded 1000ppm, for 9 hours on the ground floor and for 14 hours on the 1<sup>st</sup> floor. The max CO<sub>2</sub> level on the ground floor was 1409 ppm (for 10 min) and around 1300ppm on the 22 of October between 12-14, as shown in Figure 13.

Figure 13 CO<sub>2</sub> concentration on the ground floor during experiment 2 (17 -22 October 2013)

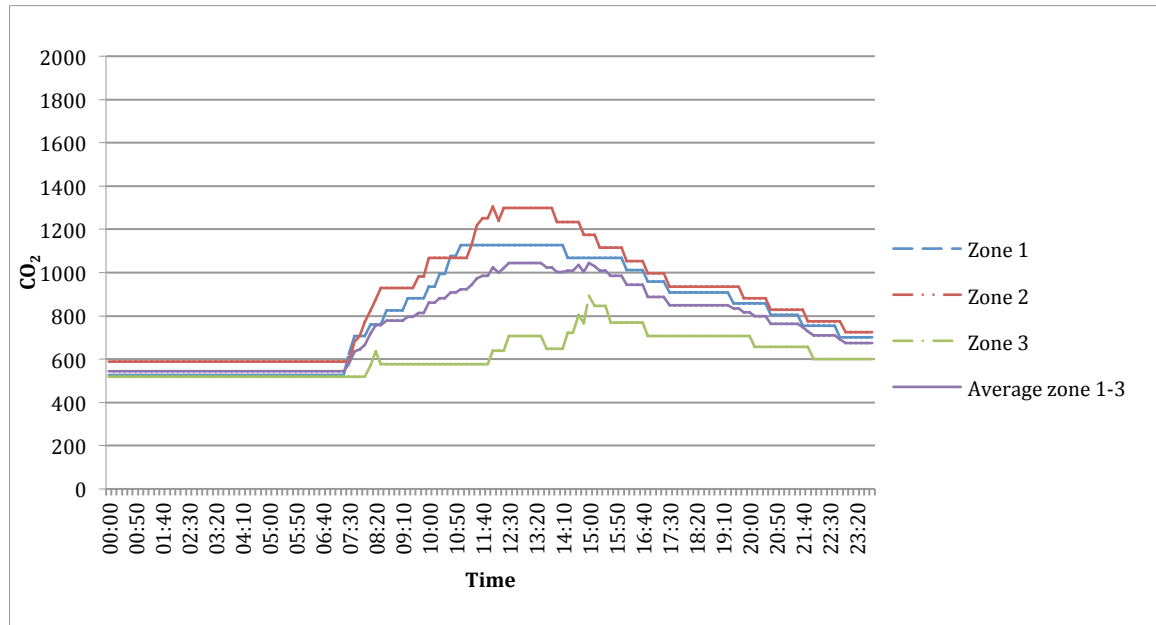
The measurement results showed that the average quality of the air in the rooms was moderate, where the average of the CO<sub>2</sub> concentration was below 1000 ppm most of the time, as shown in the Figure 15. The highest concentration was recorded in Zone 2, where the extraction to the chimney is placed.

Figure 15 CO<sub>2</sub> concentration on the ground floor during October 21 2013

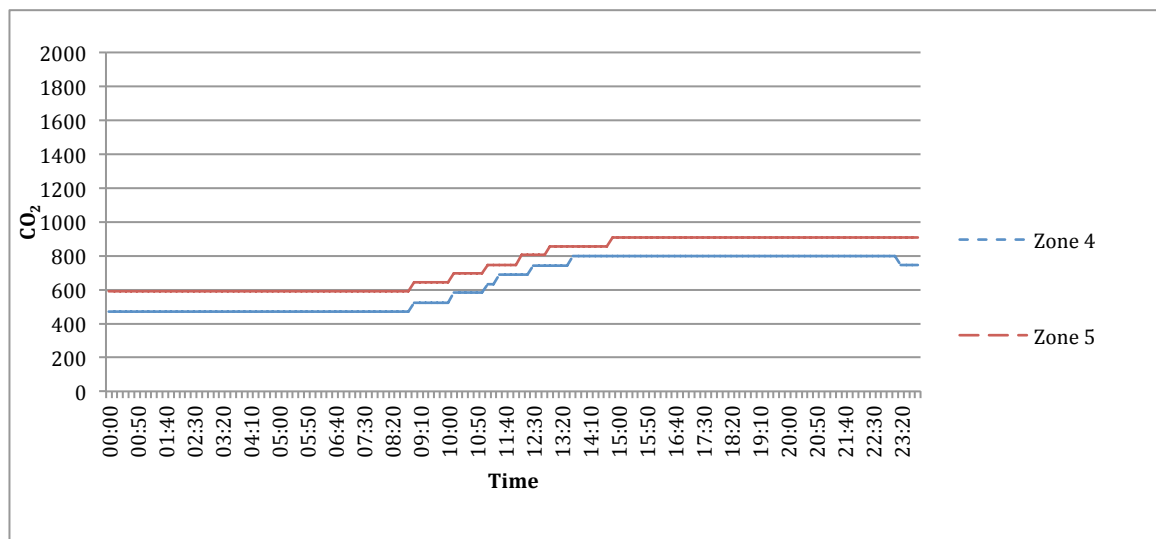
The room on the 1<sup>st</sup> floor was not occupied during 21<sup>th</sup> of October. However, the CO<sub>2</sub> concentration was still slightly higher during the occupant period as shown in Figure 16.

Figure 16 CO<sub>2</sub> concentration on 1st floor on the 21 October 2013

The reason for that could be that the chimney 2 supports both floors and the polluted air from the ground floor escapes not only through the chimney 2 but also entered the 1<sup>st</sup> floor. We noticed a similar case during one visit to the building, where the 1<sup>st</sup> floor was unoccupied and the internal windows were closed. By opening internal windows the CO<sub>2</sub> levels dropped, indicating that the air flow was directed back to the chimney.

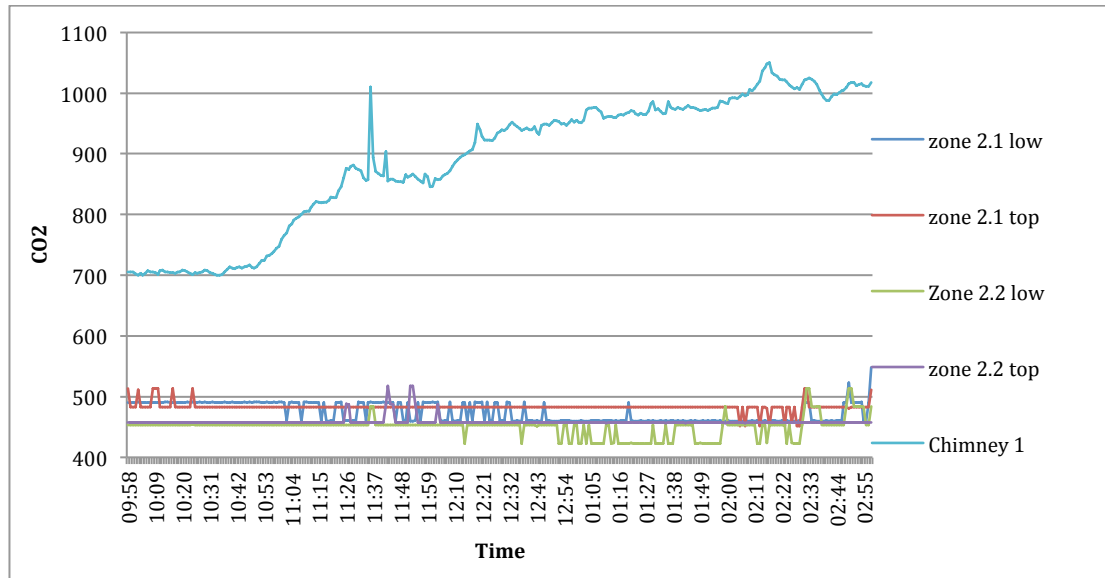
The CO<sub>2</sub> concentration at the bottom of the windows on the ground floor hardly varied and was lower than in the top of the window, which indicated that the incoming air did not mixed with the incoming air.

Figure 17 The levels of CO<sub>2</sub> concentration in windows in Zone 2 and in the Chimney 2, which is the closest to the windows openings.

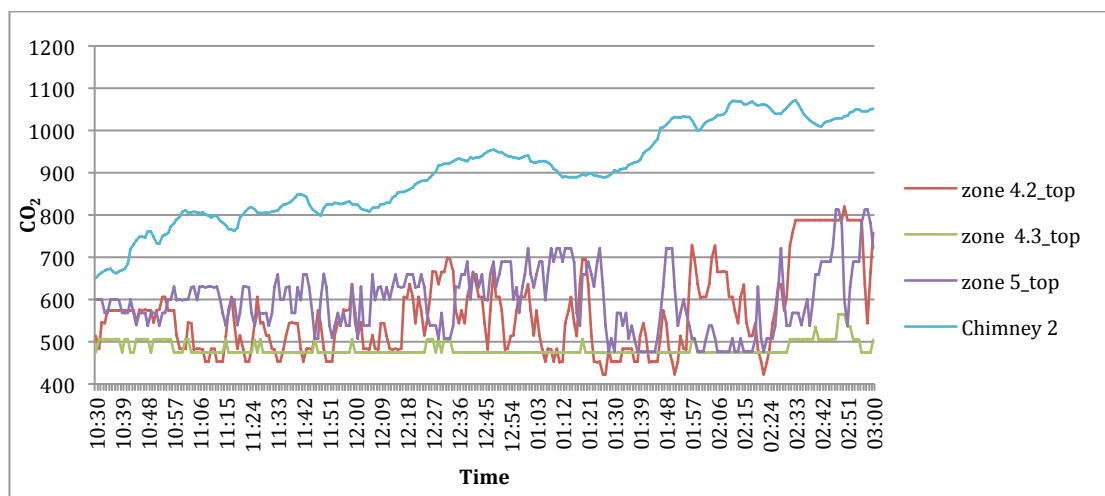
Other windows, which had a longer distance to the chimneys, such as window 1.1 in Zone 1 on the ground floor, window 4.2 in Zone 4 and window 5.1 in Zone 5, (Figure 18), worked as both supply and extract.

Figure 18 The levels of CO<sub>2</sub> concentration in windows in Zone 4 on the 1<sup>st</sup> floor and in the Chimney 2, which is the closest to the windows openings.

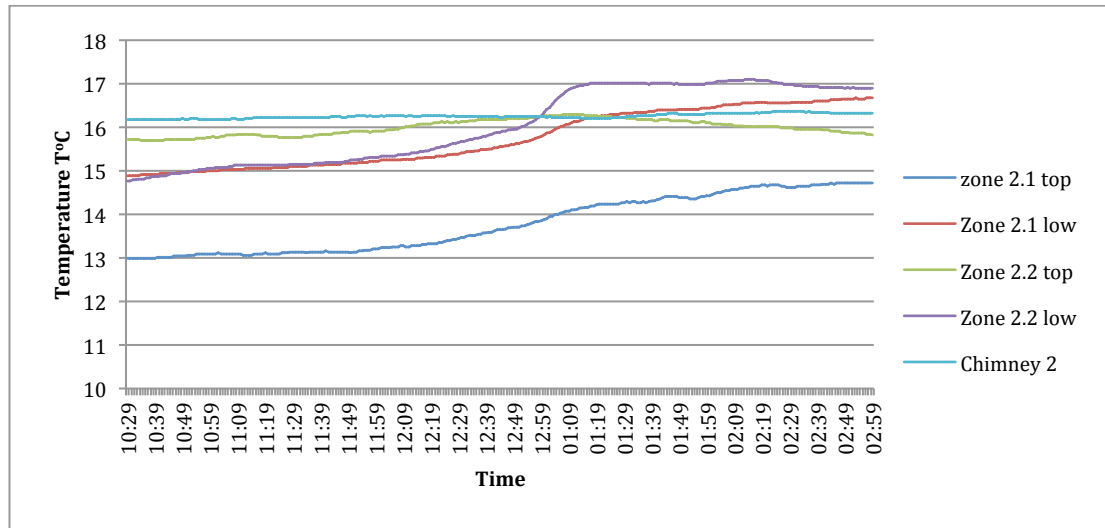
The incoming temperature through the ventilation windows was stable and varied from 13 -16°C at the top of the window and was at least 2-3°C warmer at the bottom of the windows (Figure 19). As the temperature difference was so small between the top and the bottom of the window it was not clear whether the incoming air mixed with the air in the gap.

Figure 19 The temperatures in the top and the bottom of the windows in Zone 2, which were working as inlets.

The temperature in the rooms was between 21-23°C during the occupied hours, therefore the incoming air at 13-16°C could possibly create a feeling of draft for the occupants. From the experiment we were not able to determine the temperature of the incoming air.

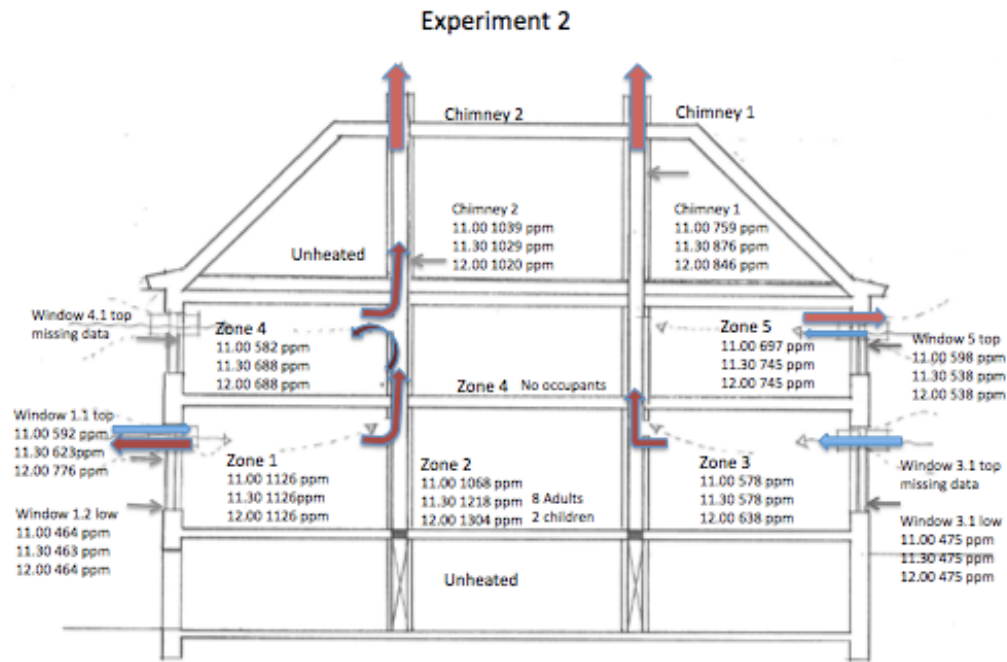
The results are summarised in Figure 20 for the 21<sup>st</sup> of October between 11-12am. During this period the occupants on the ground floor were usually in zone 3 on the ground floor preparing and eating lunch.

**Figure 20 Summary of the experiment 2**

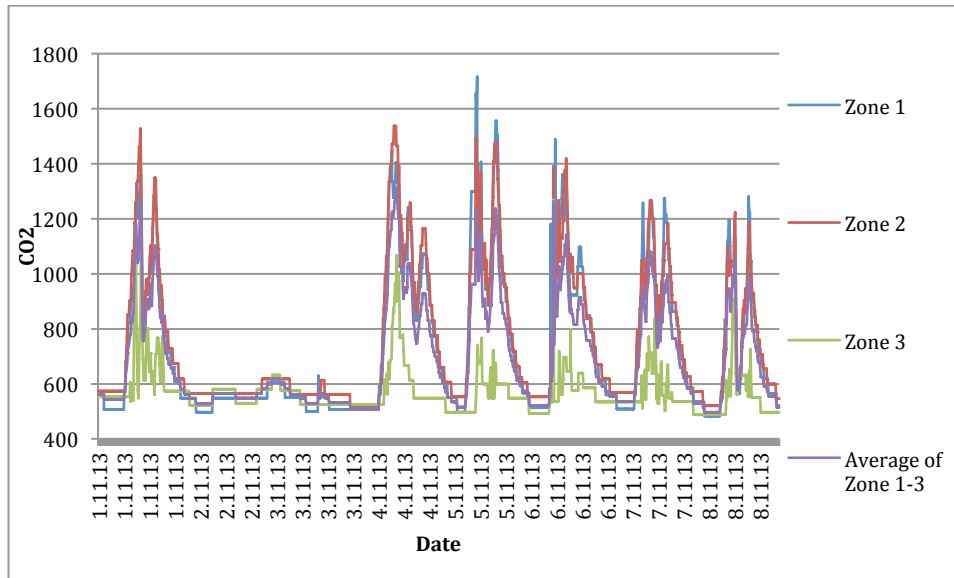
The highest CO<sub>2</sub> levels were recorded on the 4<sup>th</sup> of November 2013 in Zone 5 on the 1<sup>st</sup> floor and in Zone 4 on the 1<sup>st</sup> floor on the 7<sup>th</sup> of November 2013. During the 4<sup>th</sup> of November, Windows Masters forgot to set the automatic control of windows. Therefore, the fully functional system was only available from the 5<sup>th</sup> of November as shown in Figure 21.

Figure 21 CO<sub>2</sub> concentrations in the rooms during Experiment 3

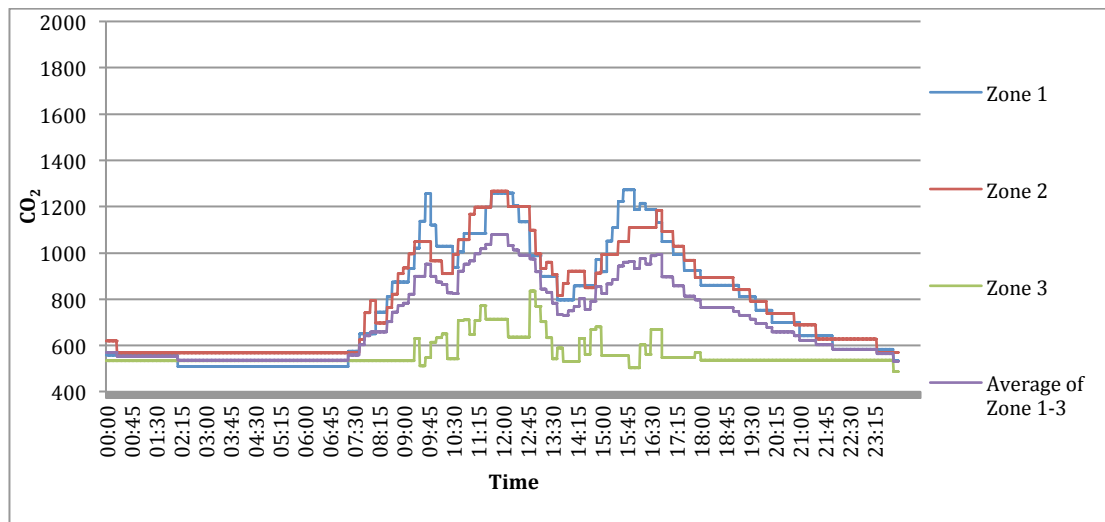
To be able to keep the CO<sub>2</sub> levels below 1000ppm, the air change needed to be a 0.98 ach. The measured average CO<sub>2</sub> concentration for 1-3 zones was 1079 ppm, which is considered good, however in Zone 1 and Zone 2 the CO<sub>2</sub> concentration was 1258 and 1266 respectively, as shown in Figure 22. The average low CO<sub>2</sub> concentration is due to the low concentration in Zone 3. Knowing the actual concentration, I estimated that actual air change for the average of zone 1-3 to be 0.87 ach.

Figure 22 CO<sub>2</sub> concentration on the ground floor in zone 1-3 during occupancy on the 7<sup>th</sup> of November 2013

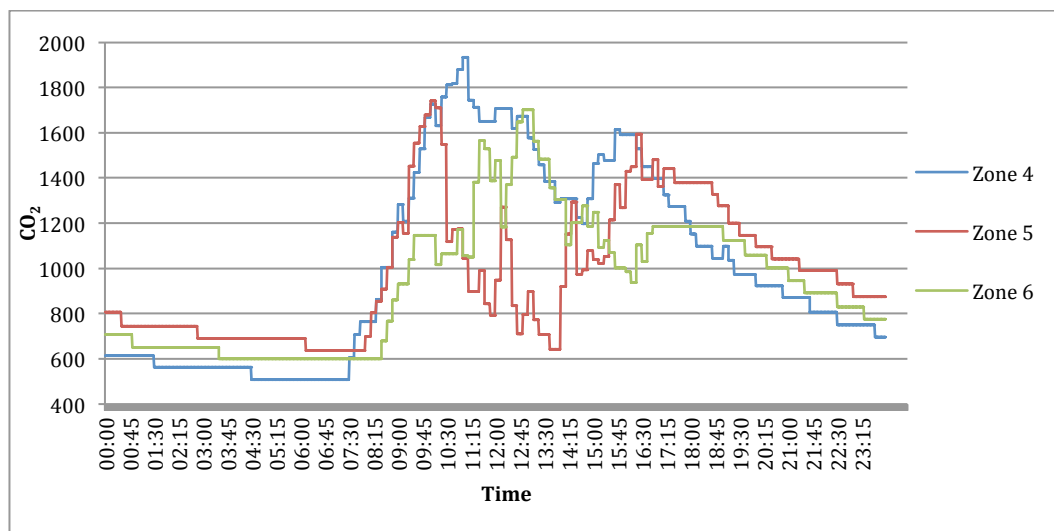
In the room on the 1<sup>st</sup> floor, CO<sub>2</sub> concentration was higher, reaching 1934ppm during a 10 min period in Zone 4 and varying between 1200 and 1700ppm during the occupancy, as shown in Figure 23. The high CO<sub>2</sub> concentration also appears in Zone 6, which is the separate office with one occupant. We did not investigate Zone 6 because the occupant was feeling a draught from the window and had the window closed most of the time.

Figure 23 CO<sub>2</sub> concentrations on the 1<sup>st</sup> floor during November 7<sup>th</sup> 2013.

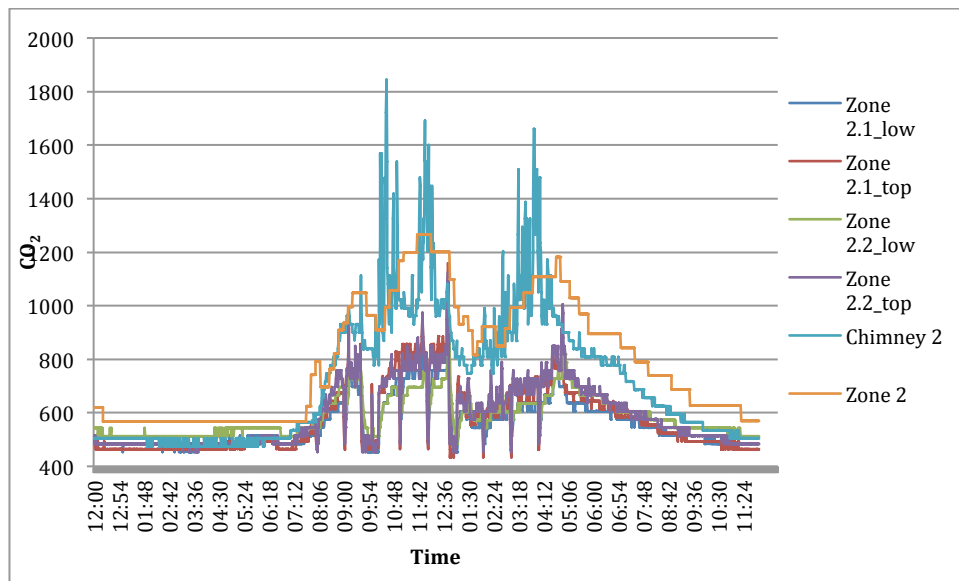
The meters installed in the windows and chimneys showed that the concentration of CO<sub>2</sub> in the chimneys was higher than in the rooms on the ground floor, as shown in the Figure 24. It indicated, that even though the air flow in the chimneys were fluctuating, the chimney 2 was still working as an extractor most of the time, and the windows 2.1 and 2.2 in Zone 2 were working as air supply. During a 3 min period each hour, when the external windows opened, the CO<sub>2</sub> levels dropped in the windows on the south façade as well as in the chimney 2. It is not clear whether the opening of the external windows increased the air exchange in the rooms by increasing the air velocity, or it disturbed the airflow and reversed the airflow in the chimney 2.

Figure 24 CO<sub>2</sub> concentration in the zone 2(south façade) on the 7<sup>th</sup> of November.

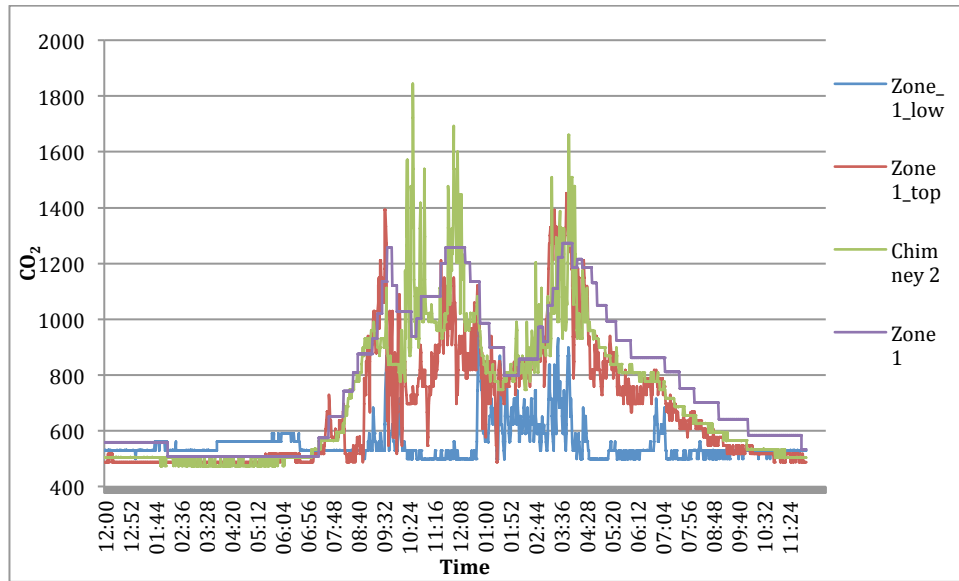
As the wind direction was from the south-west, the window on the east facing façade 1.1 on the ground floor worked both as an extractor and supply, as shown in Figure 24. The window 4.1 on the 1<sup>st</sup> floor worked mostly as an extractor, as the CO<sub>2</sub> concentration was highest, as shown in Figure 25.

Figure 25 CO<sub>2</sub> concentration in Zone 1 (east facing façade) on the 7<sup>th</sup> of November 2013.

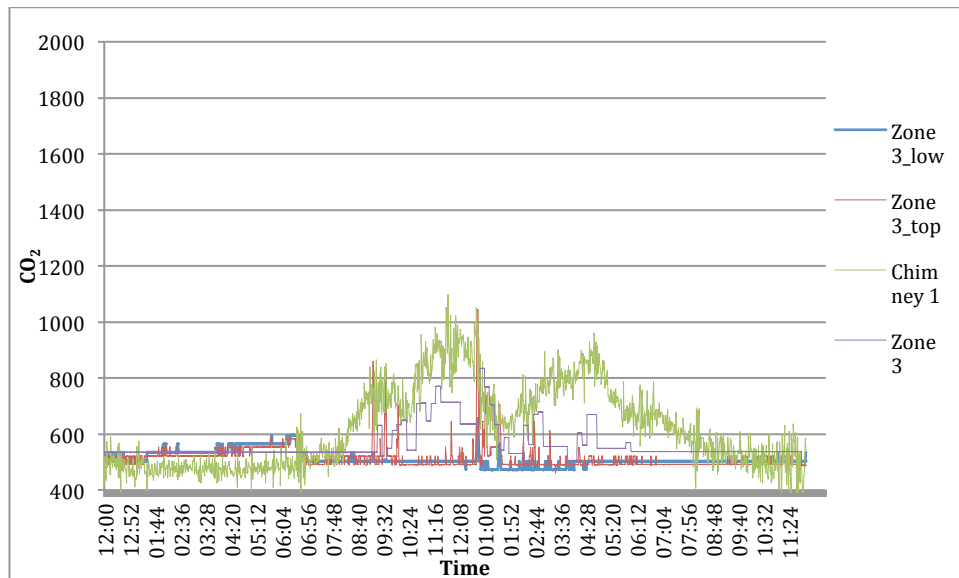
The window 3.1 on the west facing façade on the ground floor worked as an air supply with the lowest CO<sub>2</sub> concentration recorded in Zone 3 (Figure 26). Chimney 1 is located in the same room and worked mostly as an extractor. Zone 3 had the best air quality in the building, which was possible influenced by the wind direction as the wind direction was south west.

Figure 26 CO<sub>2</sub> concentration in Zone 3 on the ground floor during the 7<sup>th</sup> of November 2013

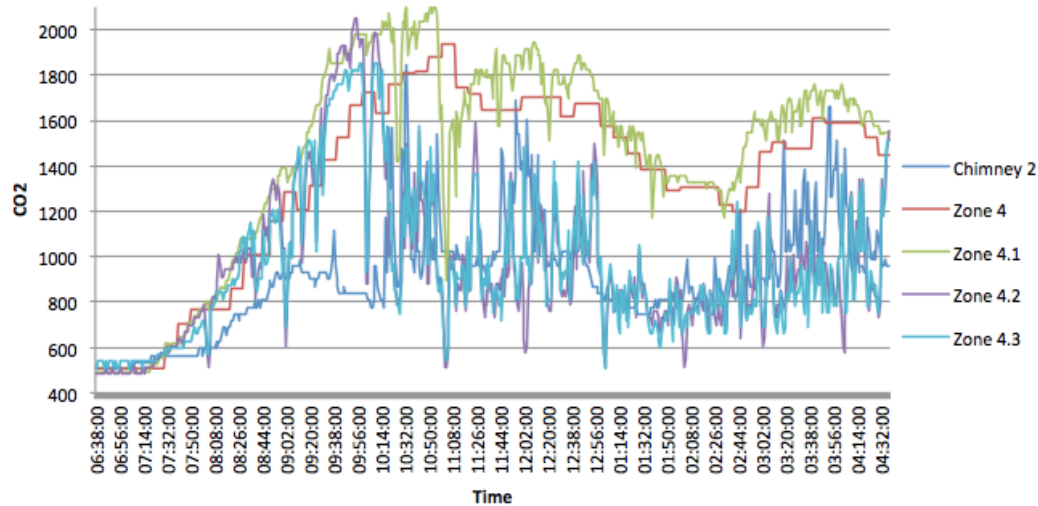
As chimney 2 was working as the air extractor for both floors, the high CO<sub>2</sub> concentration in chimney 2 could also be caused by the average higher CO<sub>2</sub> concentration on the 1<sup>st</sup> floor, as shown in Figure 27.

Figure 27 CO<sub>2</sub> concentration in the zone 4 (south façade) on the 1<sup>st</sup> floor during 7<sup>th</sup> of November 2013.

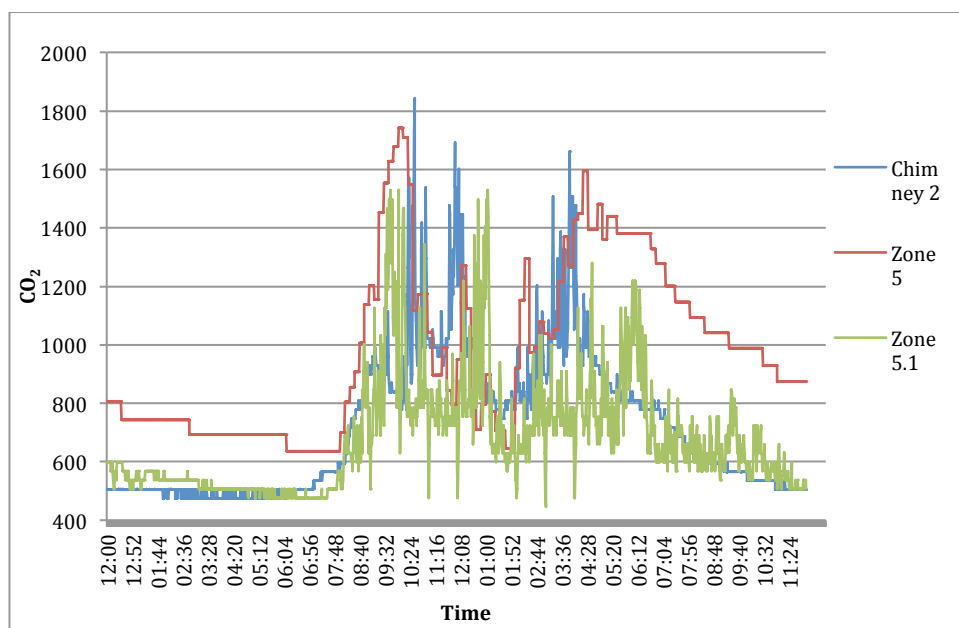
The relatively lower CO<sub>2</sub> concentration, with high fluctuation was also recorded in window 5.1 in Zone 5 on the 1<sup>st</sup> floor (Figure 28). Note that Zone 5 has no direct connection to chimney and is connected to chimney 2 through an opening between zone 4 and 5. Therefore window 5.1 works both as a supply and extractor.

Figure 28 CO<sub>2</sub> concentration in Zone 5 on the 1<sup>st</sup> floor during the 7<sup>th</sup> of November 2013

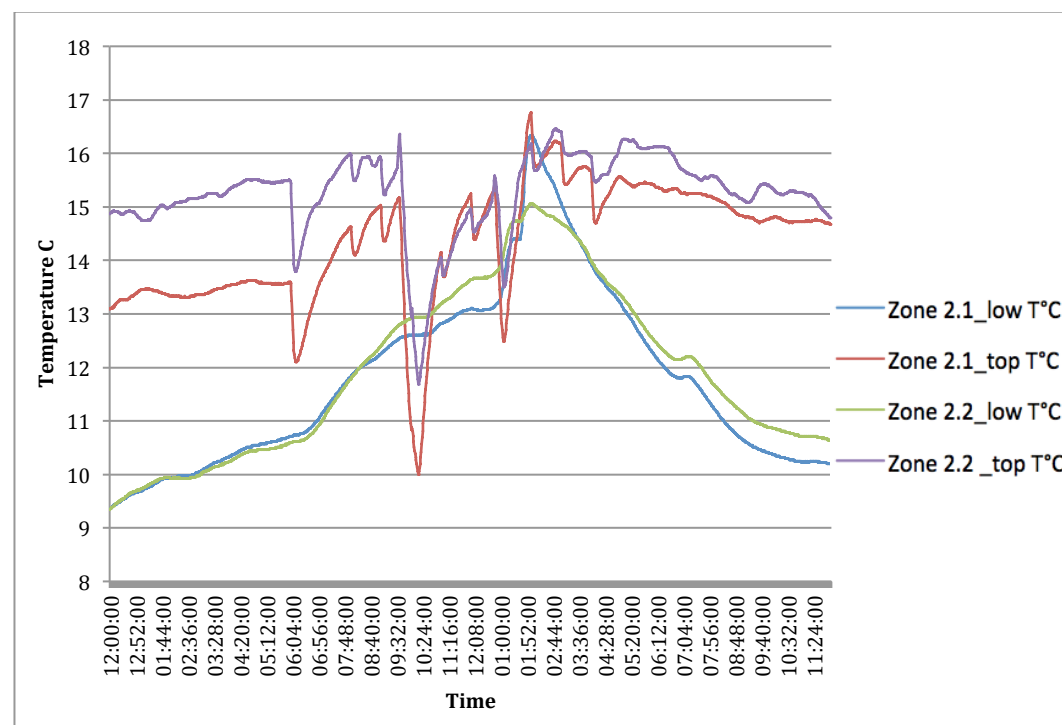
The temperature difference between the top and the bottom of the windows was changing during the occupied hours, indicating that there was probably some kind of mixing of the air in the gap of the window. Note, that the temperature in the lower part of the window was cooler than in the top, which indicated that the air was coming in through the leakage in the external frame, as predicted, and was different from experiment 2 where the temperature in the top was cooler.

Figure 29 Temperature in the gaps in windows 2.1 and 2.2 in Zone 2 on the 7th of November 2013

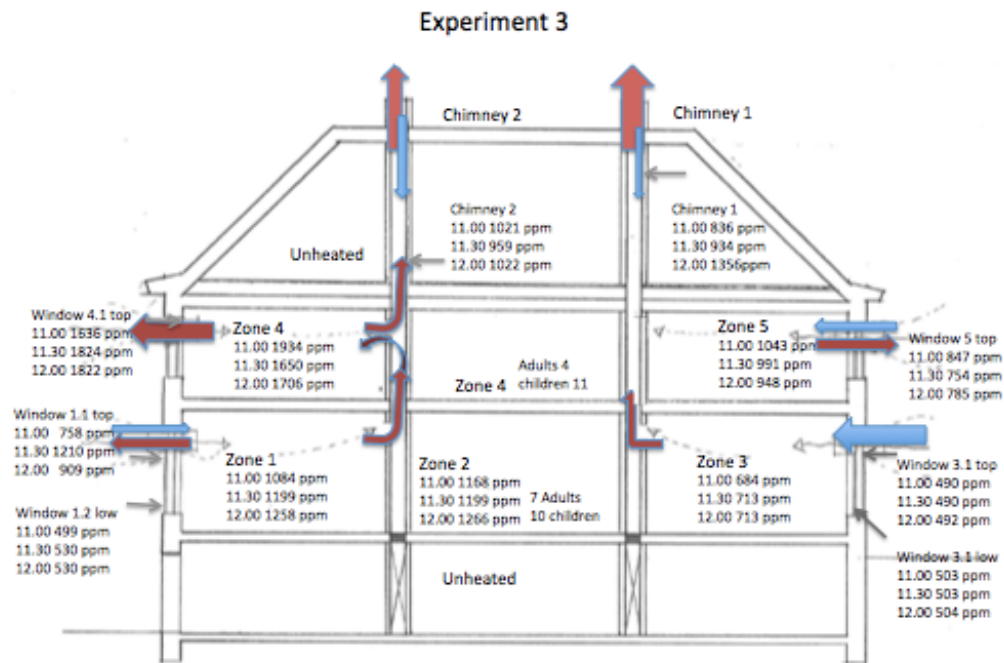
The results are summarised in Figure 30 during the 7<sup>st</sup> of November 2013 between 11-12am. During this period, the occupants on the ground floor were in zone 3 on the ground floor and in Zone 4 at the 1<sup>st</sup> floor preparing and eating lunch.

**Figure 30 Summary of Experiment 3**
